Appendix A: Dust Monitoring Data

Subsidence – Stage 3 End of Panel Report, Longwall A7

END OF PANEL REPORT- STAGE 3 LONGWALL A7

Austar Coal Mine Pty Ltd (Austar) completed extraction of Longwall A7 on 19 April 2014. Austar submits this End of Panel report for Longwall A7 in accordance with Condition 18 of Subsidence Management Plan (SMP) Approval for Austar Coal Mine Longwalls A7 to A10 (File No. 13/1867, approved on 3 June 2013).

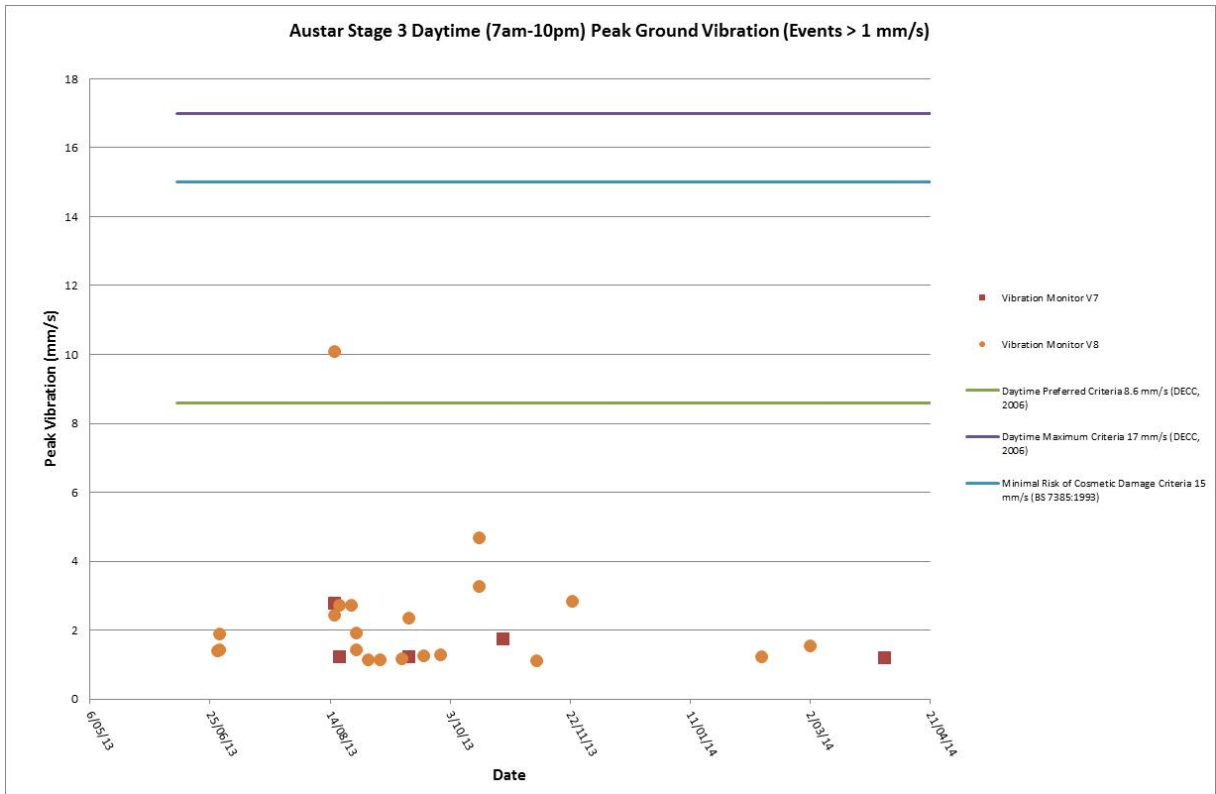
Figure 3.2 Vibration Monitoring Results – Daytime

Results indicate that vibration from the extraction of Longwall A7 has been event based in nature, typically generated by strata failures from material overlying the mining area. The majority of vibration events are less than 4 mm/sec, with only 2 events greater than 6 mm/sec over the period of extraction of A7. There were no events greater than 11.7 mm/sec.

No events exceeded the guideline value where a minimal risk of cosmetic damage to building structures may occur (15mm/sec).

As noted in the DGS comment, it is not practical to impose operational constraints on the mine to reduce vibration events. To manage vibration, Austar has continued to provide adequate community access to vibration monitoring information in regular underground mine status reports to landholders over the active Stage 3 mining area. These status reports include vibration monitoring and mining status information to affected residents.

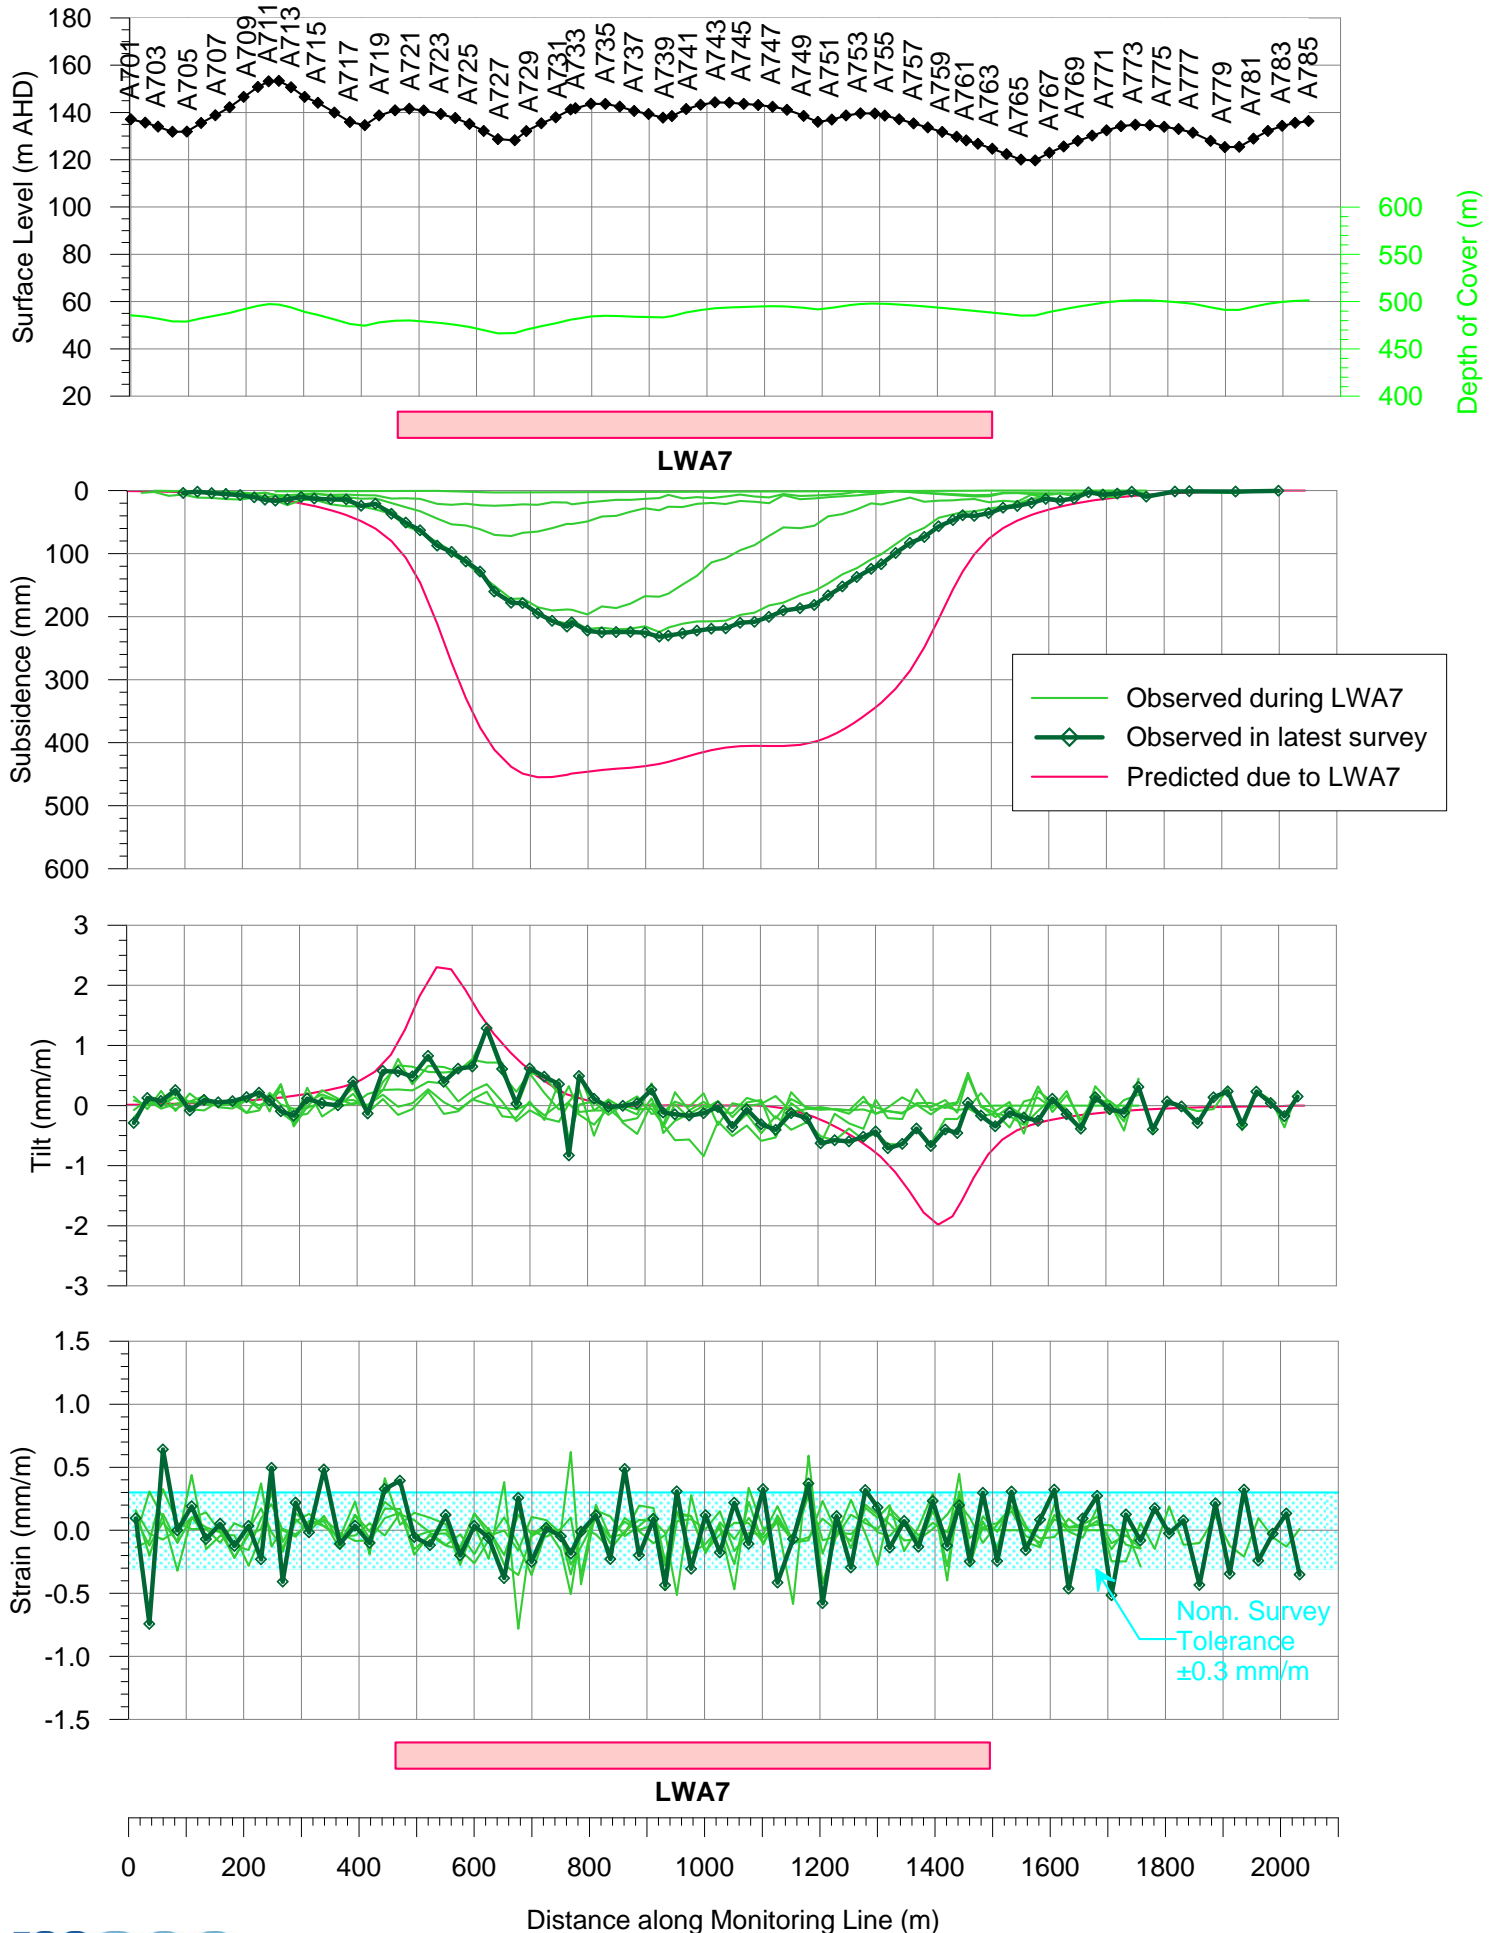
Observed and Predicted Profiles of Incremental Subsidence, Tilt and Strain along the A7-Line during Austar Stage 3 LWA7

The observed profiles of incremental subsidence, tilt and strain along Line A7, resulting from the extraction of Longwall A7, are shown in Fig. A.01, in Appendix A. The predicted profiles of incremental subsidence and tilt along this monitoring line, after the completion of the longwall, are also shown in this figure for comparison.

The maximum observed incremental subsidence along Line A7 was 232 mm, which represents 52 % of the maximum predicted subsidence of 450 mm. Similarly, the maximum observed tilt of 1.3 mm/m represented 52 % of the maximum predicted tilt.

The observed subsidence and tilt profiles were reasonably symmetrical, but the subsidence profile was slightly flatter (i.e. lower tilt) at the longwall finishing end (i.e. left side of Fig. A.01). A localised bump (i.e. uplift) developed in the subsidence profile at Mark A733, however, it was not associated with any elevated strains and was not considered anomalous.

The maximum observed incremental strains along Line A7 were 0.6 mm/m tensile and 0.8 mm/m compressive. The maximum predicted conventional strains, based on applying a factor of 15 to the maximum predicted conventional curvatures anywhere above Longwall A7, are 0.6 mm/m tensile and 0.9 mm/m compressive.

The maximum observed strains occurred in adjacent survey bays (i.e. as a tensile-compressive pair) and were located outside of the extents of the longwall and, therefore, could be the result of a disturbed survey mark. Elsewhere, the observed strains were typically in the order of survey tolerance (i.e. 0.3 mm/m), with localised strains up to 0.5 mm/m tensile and compressive.

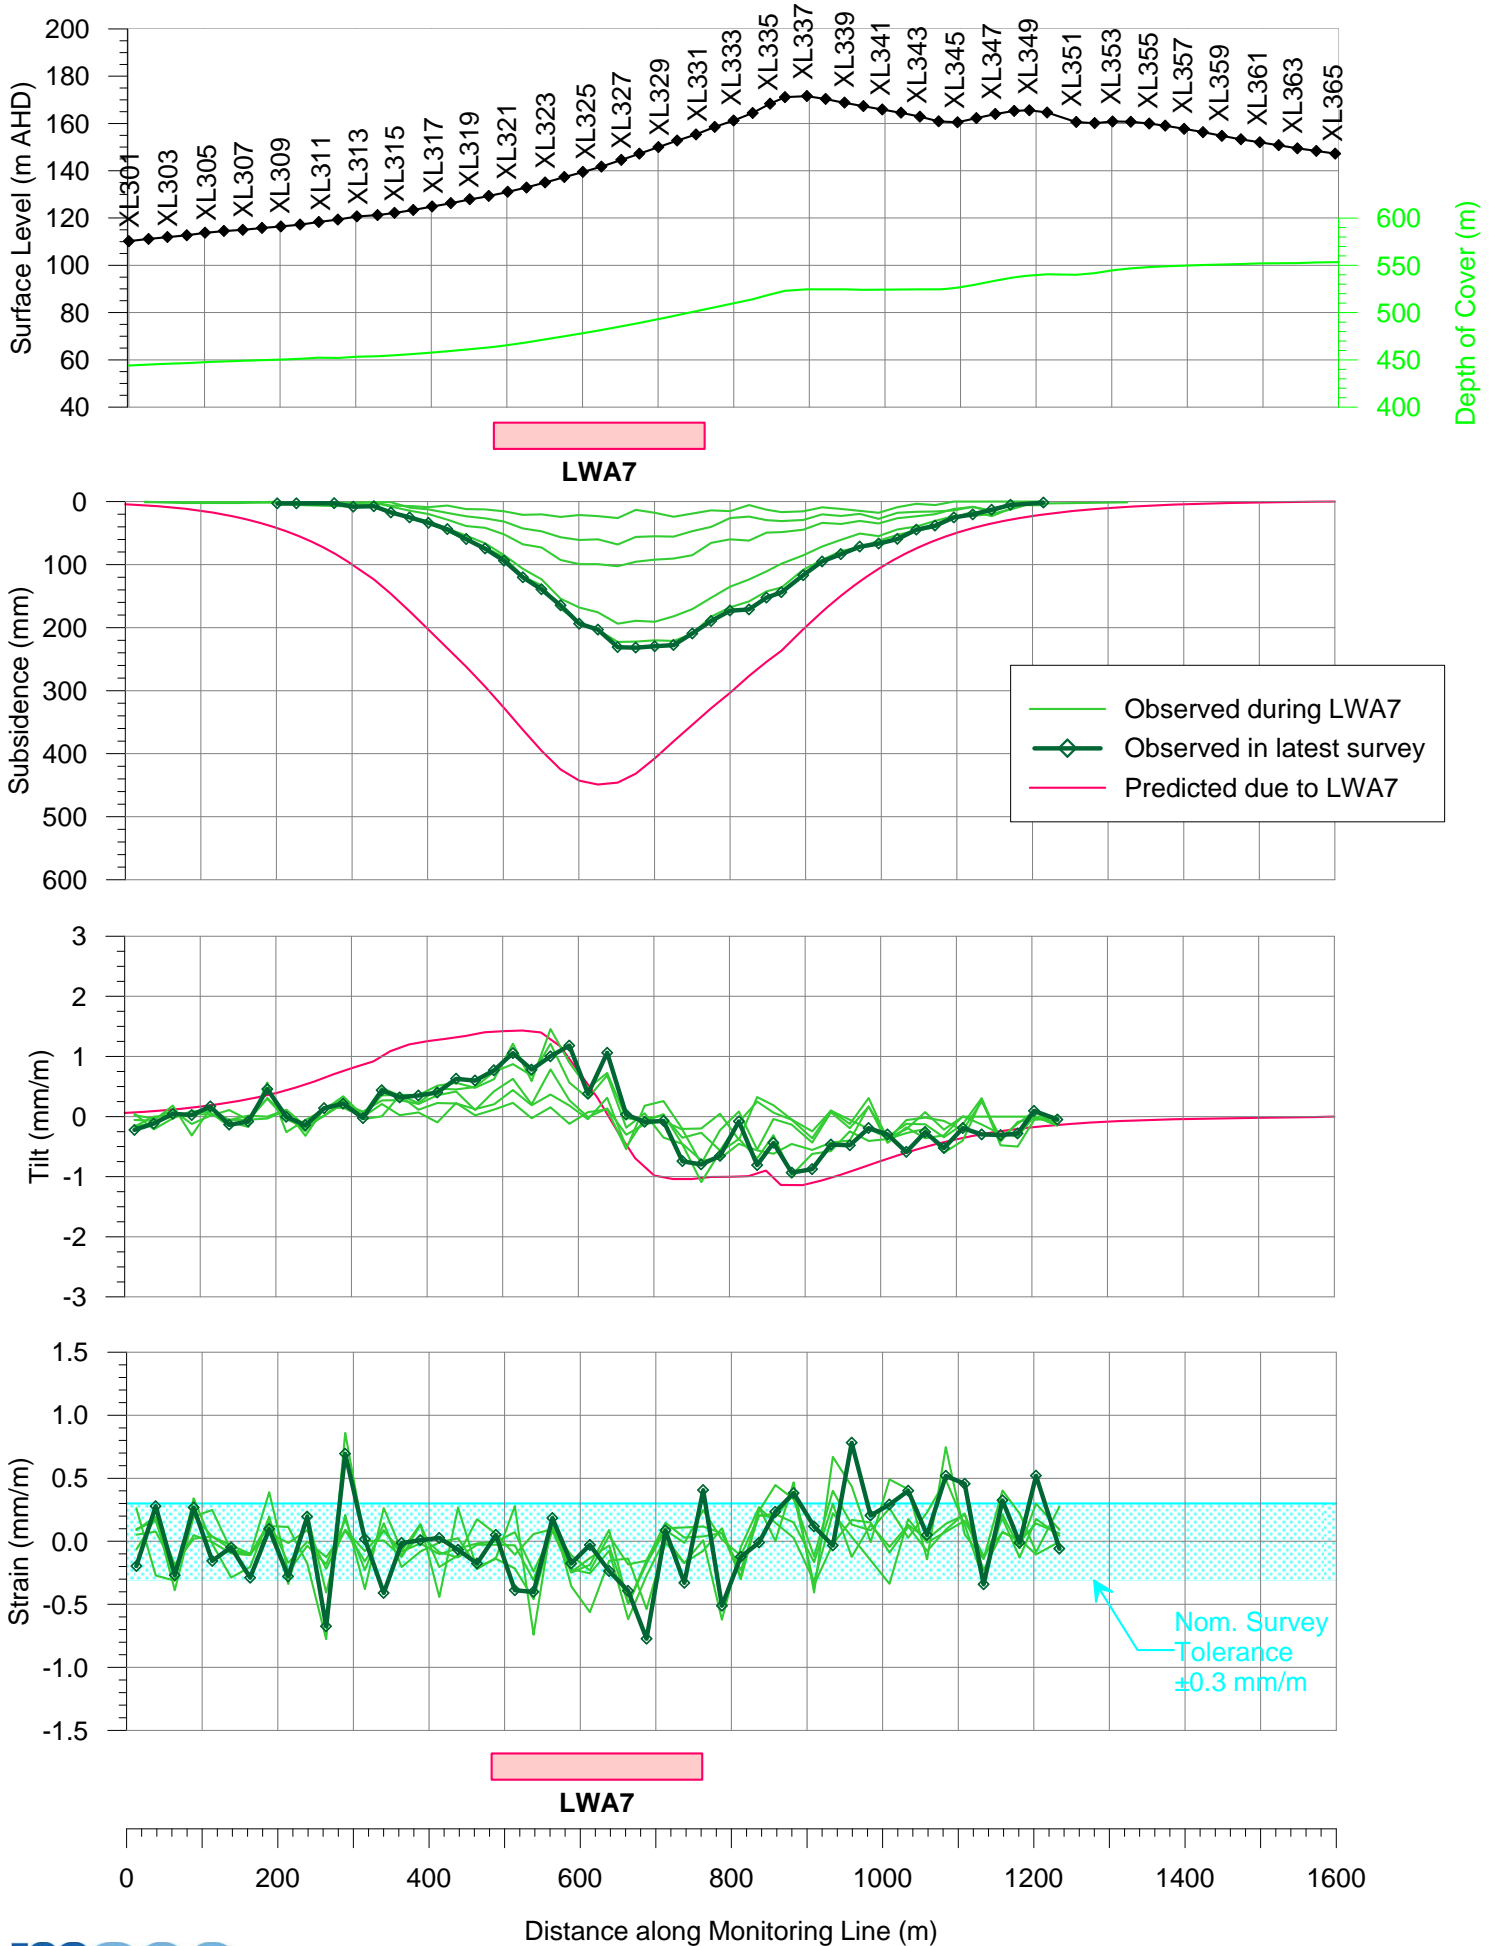
Observed and Predicted Profiles of Incremental Subsidence, Tilt and Strain along the XL3-Line during Austar Stage 3 LWA7

The observed profiles of incremental subsidence, tilt and strain along Line XL3, resulting from the extraction of Longwall A7, are shown in Fig. A.02, in Appendix A. The predicted profiles of incremental subsidence and tilt along this monitoring line, at the completion of Longwall A7, are also shown in this figure for comparison.

The maximum observed incremental subsidence along Line XL3 was 232 mm, which represents 52 % of the maximum predicted subsidence of 450 mm (as per Line A7). The shape of the observed subsidence profile reasonably matched the predicted subsidence profile, but with a reduced magnitude. There is a slight lateral shift in the observed subsidence profile, towards the longwall maingate (i.e. right side in Fig. A.02), which could be the result of the natural surface slope.

The maximum observed incremental tilt was 1.5 mm/m which was the same as the maximum predicted tilt. The observed tilt profile also reasonably matched the predicted tilt profile. The observed tilt locally exceeded the predicted tilt between Marks XL326 and XL327, due to the localised bump (i.e. uplift) in the subsidence profile at Mark XL326. The localised bump was not associated with any elevated strains and, therefore, was not considered anomalous.

The maximum observed incremental strains were 0.9 mm/m tensile and 0.8 mm/m compressive. The maximum predicted conventional strains, based on applying a factor of 15 to the maximum predicted conventional curvatures anywhere above Longwall A7, are 0.6 mm/m tensile and 0.9 mm/m compressive

The maximum observed tensile strain occurs between Marks XL339 and XL340, which were located at the top of the hill and, therefore, this localised strain could have been influenced by the surface topography. The maximum observed compressive strain occurs between Marks XL328 and XL329, which were located directly above the longwall, and was less than the maxima predicted due to conventional movements.

There was a tensile-compressive strain pair (both 0.7 mm/m) located between Marks XL311 to XL313, which were located well outside the longwall and, therefore, could be the result of a disturbed survey mark. Elsewhere, the observed strains were typically in the order of survey tolerance, with some localised strains up to around 0.5 mm/m.

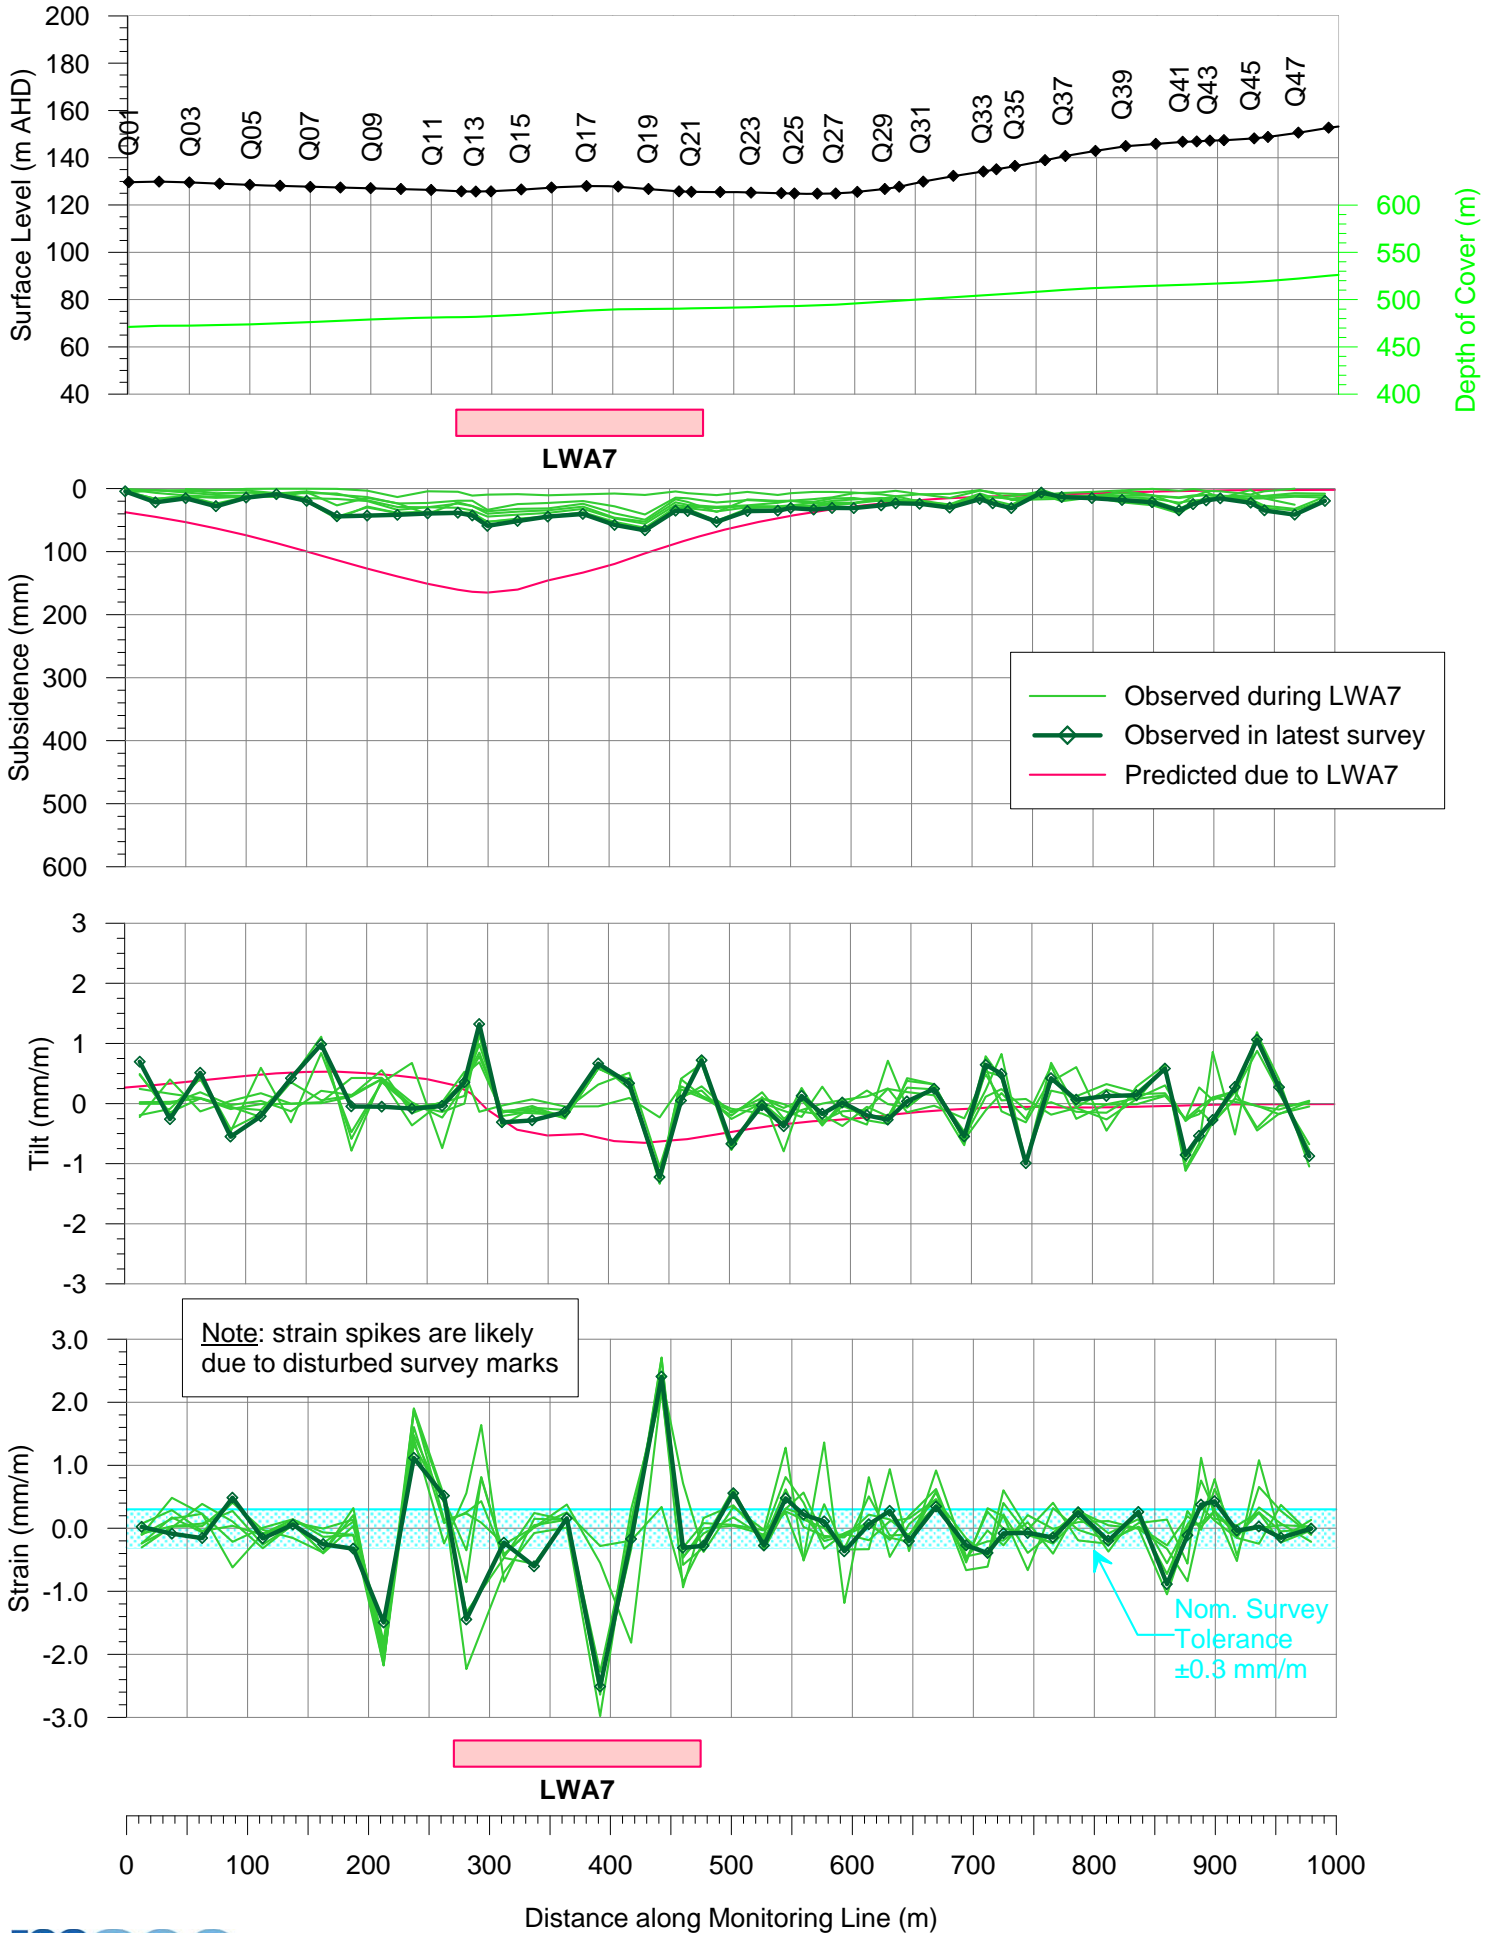
Observed and Predicted Profiles of Incremental Subsidence, Tilt and Strain along Quorrobolong Road during Austar Stage 3 LWA7

The observed profiles of incremental subsidence, tilt and strain along the Quorrobolong Road Line, resulting from the extraction of Longwall A7, are shown in Fig. A.03, in Appendix A. The predicted profiles of incremental subsidence and tilt along this monitoring line, at the completion of Longwall A7, are also shown in this figure for comparison.

The maximum observed incremental subsidence along the Quorrobolong Road Line was 66 mm, which is less than half of the maximum predicted subsidence of 150 mm. Only low level subsidence developed along this monitoring line as it crosses the corner of the longwall.

It can be seen from Fig. A.03, that the profiles of observed tilt and strain were very irregular. The localised tilts and strains along the monitoring line exceed those predicted based on conventional movements and are greater than those which would be expected based on the low level of vertical subsidence.

Only low level subsidence was measured along the Quorrobolong Road Line as this monitoring line crosses the corner of the longwall. The observed tilt and strain profiles along this monitoring line were very irregular and the localised movements appear to be the result of disturbed survey marks.
