Austar Coal Mine

Community Consultative Committee Meeting Minutes

AUSTAR COAL MINE

COMMUNITY CONSULTATIVE COMMITTEE MEETING

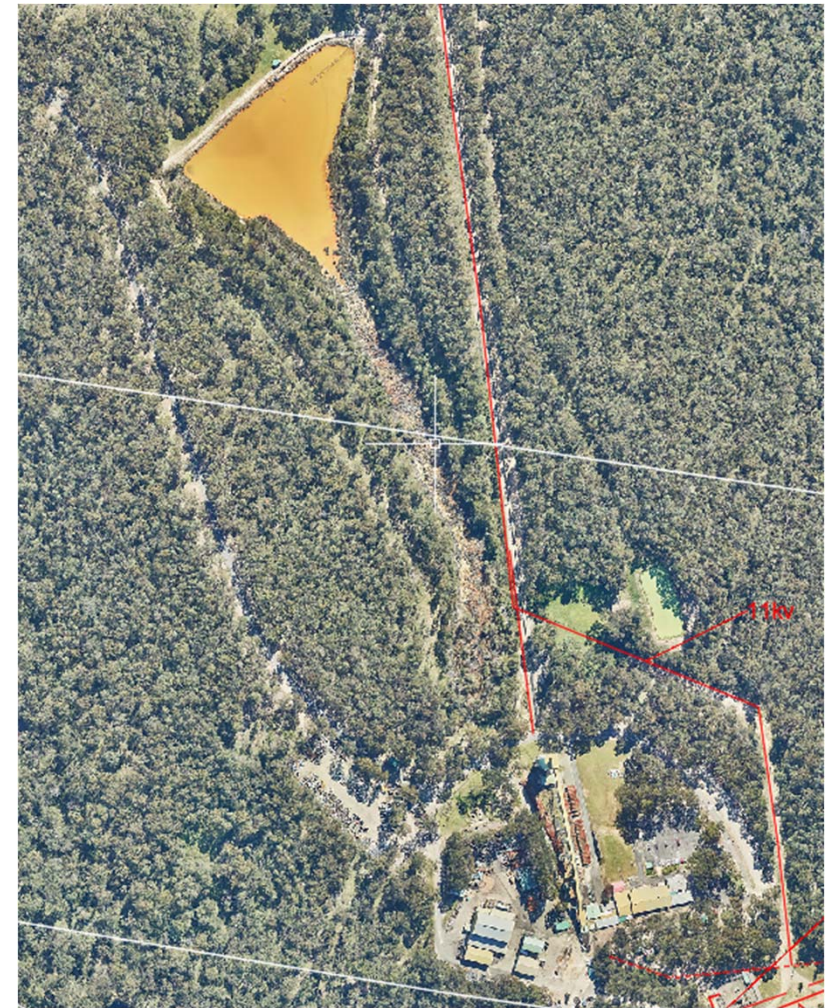
PFS – Conceptual Land Form Design Example

- Structures demolished and removed
- Austar Dam removed
- Self draining
- Blends into surrounding landscape

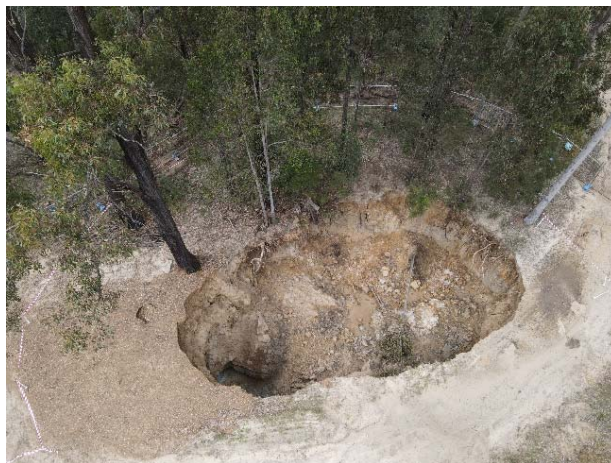
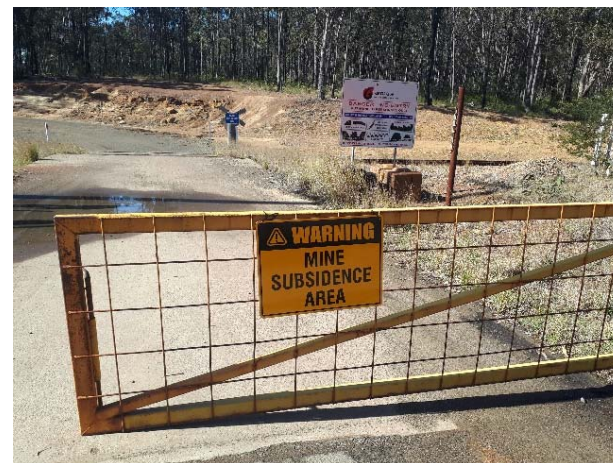
- Recently identified sinkholes in historic shallow mine workings east of Wollombi Road at Bellbird and West Cessnock as result wetter than average conditions.
- Notified Subsidence Advisory NSW who fenced area and have begun repairs.
- Austar have erected new signage and remind the public this is private property and no trespassing.
- Temporary safety fencing has been stolen on a number occasions.
- Austar plead with the Community to respect the barriers put in place for both site personnel and public safety.
