## Austar Coal Mine

### Community Consultative Committee Meeting Minutes

# AUSTAR COAL MINE

## COMMUNITY CONSULTATIVE COMMITTEE MEETING

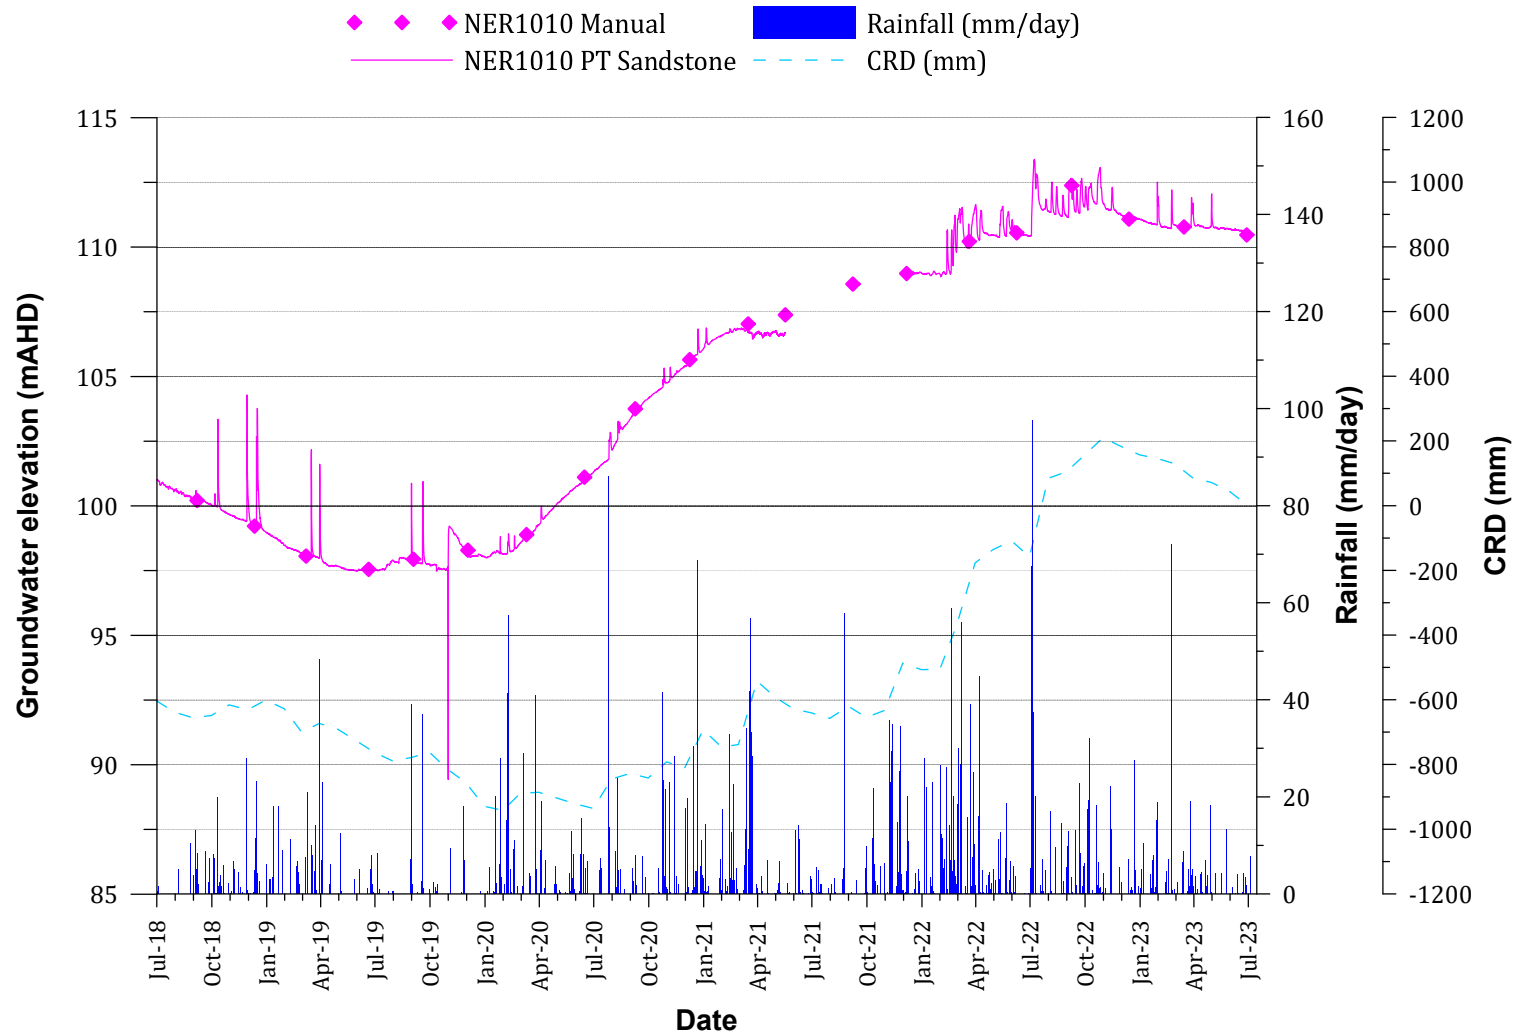
5-year NER1010 groundwater level hydrograph

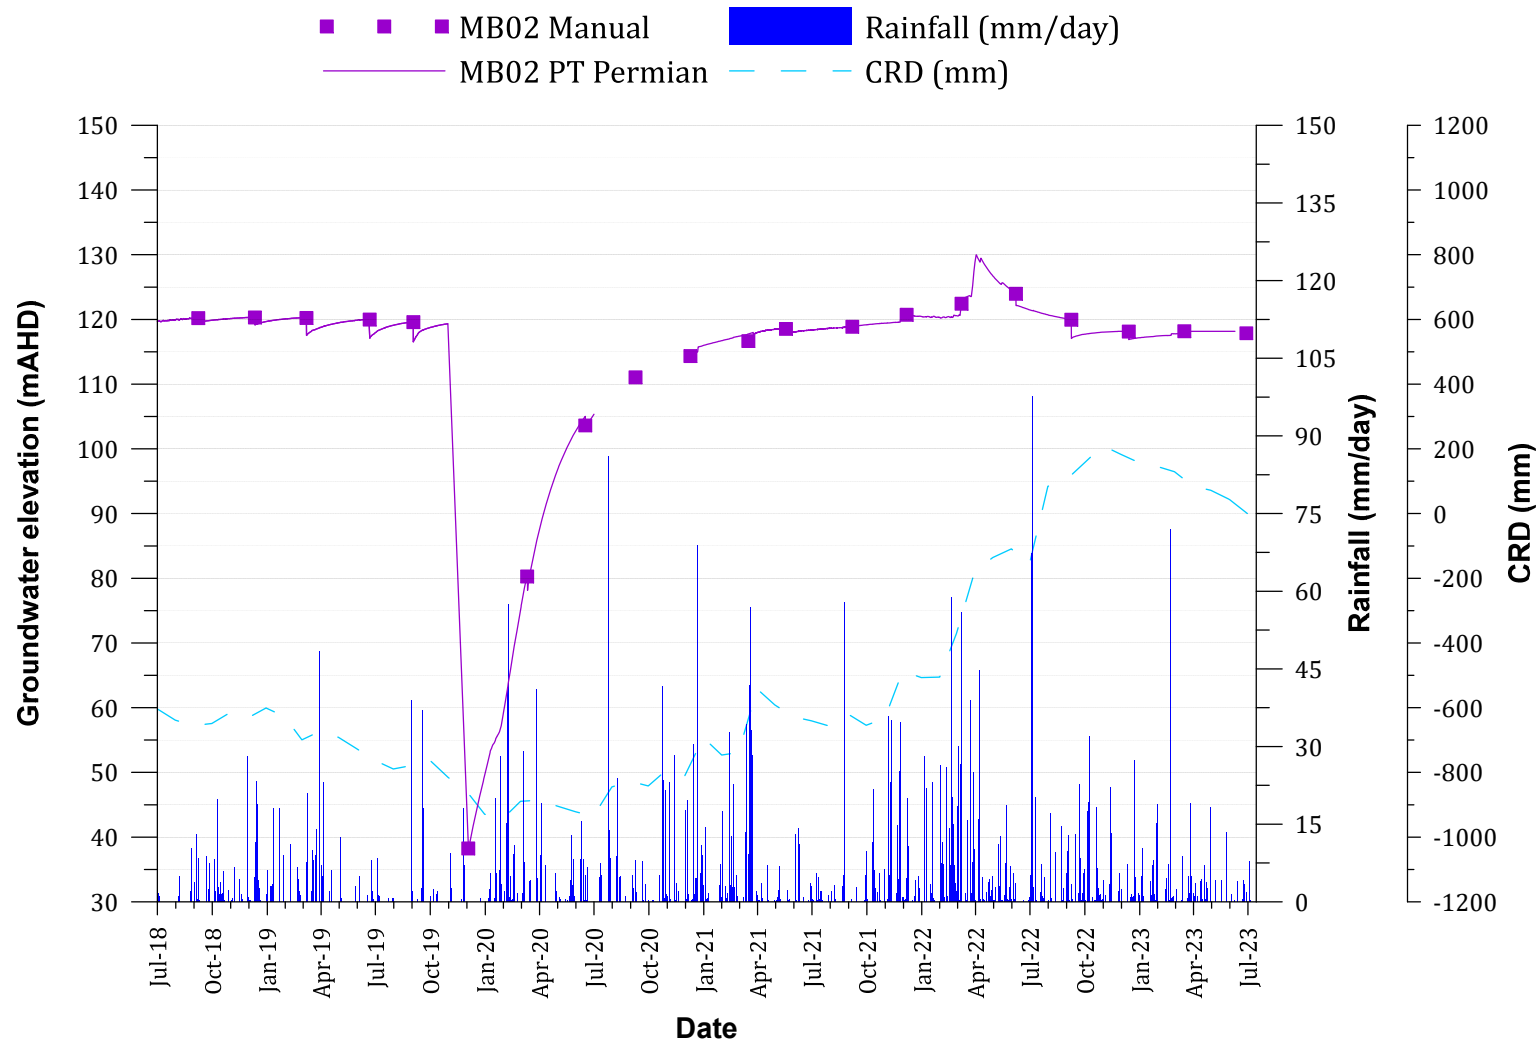
5-year Stage 3 MB02 sandstone aquifer groundwater level hydrograph

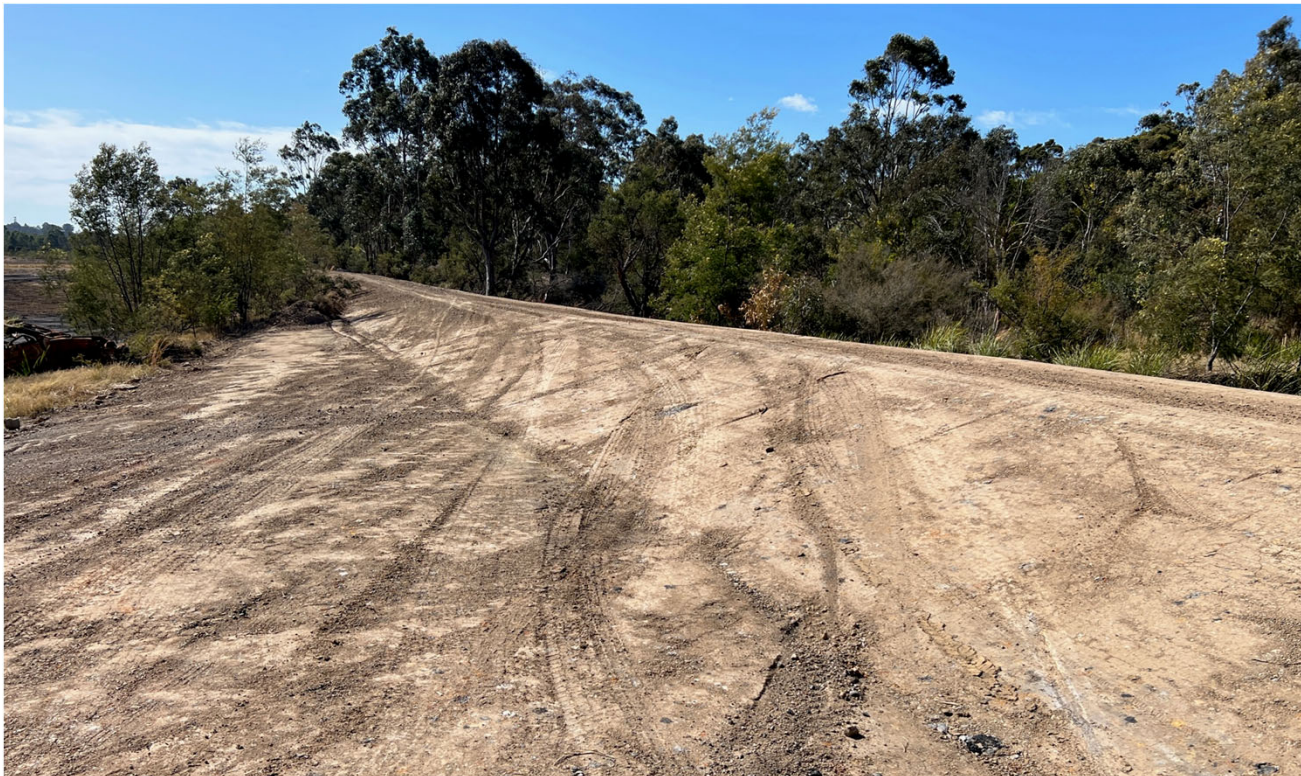
- There have been no reportable incidents or complaints since the last CCC meeting on 21 March 2023
- Aberdare Extended Emplacement Area clean water diversion drain embankment repairs have been undertaken following July 2022 incident
