Annual Environmental Management Report

July 2015 – June 2016

Name of operation	Austar Coal Mine
Name of operator	Yancoal Mining Services Pty Ltd
Development consent / project approval #	Refer Table 1.2
Name of holder of development consent / project approval	Austar Coal Mine Pty Ltd
Mining lease #	Refer to Table 1.4
Name of holder of mining lease	Austar Coal Mine Pty Ltd
Water licence #	Refer Table 1.5
Name of holder of water licence	Austar Coal Mine Pty Ltd
MOP start date	MOP 1: May 2008, MOP 2: June 2016
MOP end date	MOP 1: Nov 2016, MOP 2: Nov 2022
AEMR / Annual Review start date	1 July 2015
AEMR / Annual Review end date	30 June 2016
<p>I, Gary Mulhearn, certify that this audit report is a true and accurate record of the compliance status of Austar Coal Mine for the period 1 July 2015 to 30 June 2016 and that I am authorised to make this statement on behalf of Austar Coal Mine Pty Ltd.</p> <p><i>Note.</i></p> <p>a) <i>The Annual Environmental Management Report is an ‘environmental audit’ for the purposes of section 122B(2) of the Environmental Planning and Assessment Act 1979. Section 122E provides that a person must not include false or misleading information (or provide info

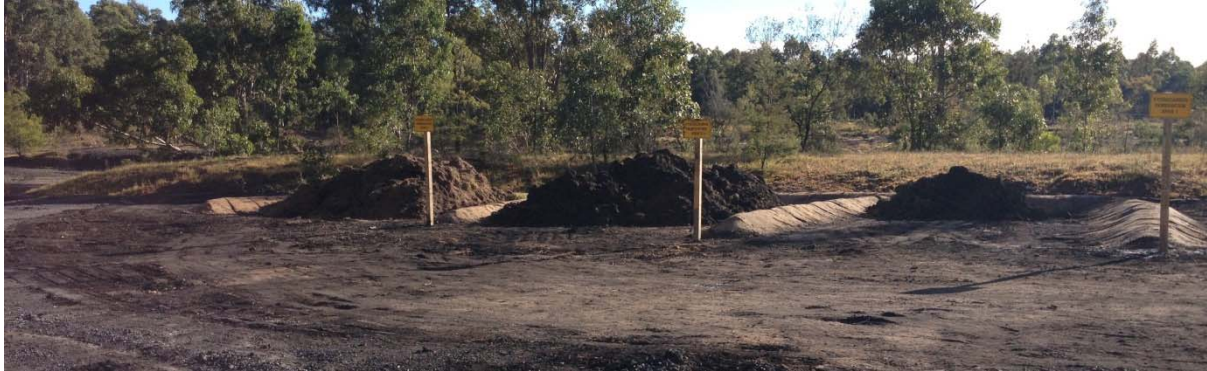
FIGURE 2.1 HYDROCARBON REMEDIATION AREA

Austar operates a hydrocarbon remediation area at the CHPP to manage hydrocarbon contaminated material retrieved from the site. As shown in **Figure 2.1** the area is signposted and has three bunded cells for segregation of materials of different ages. The bunded area was constructed on a disused

laydown area and is within the sites dirty water catchment. The contaminated materials are periodically turned to allow an adequate supply of oxygen to microbes that use the contaminants as a source of food and energy.

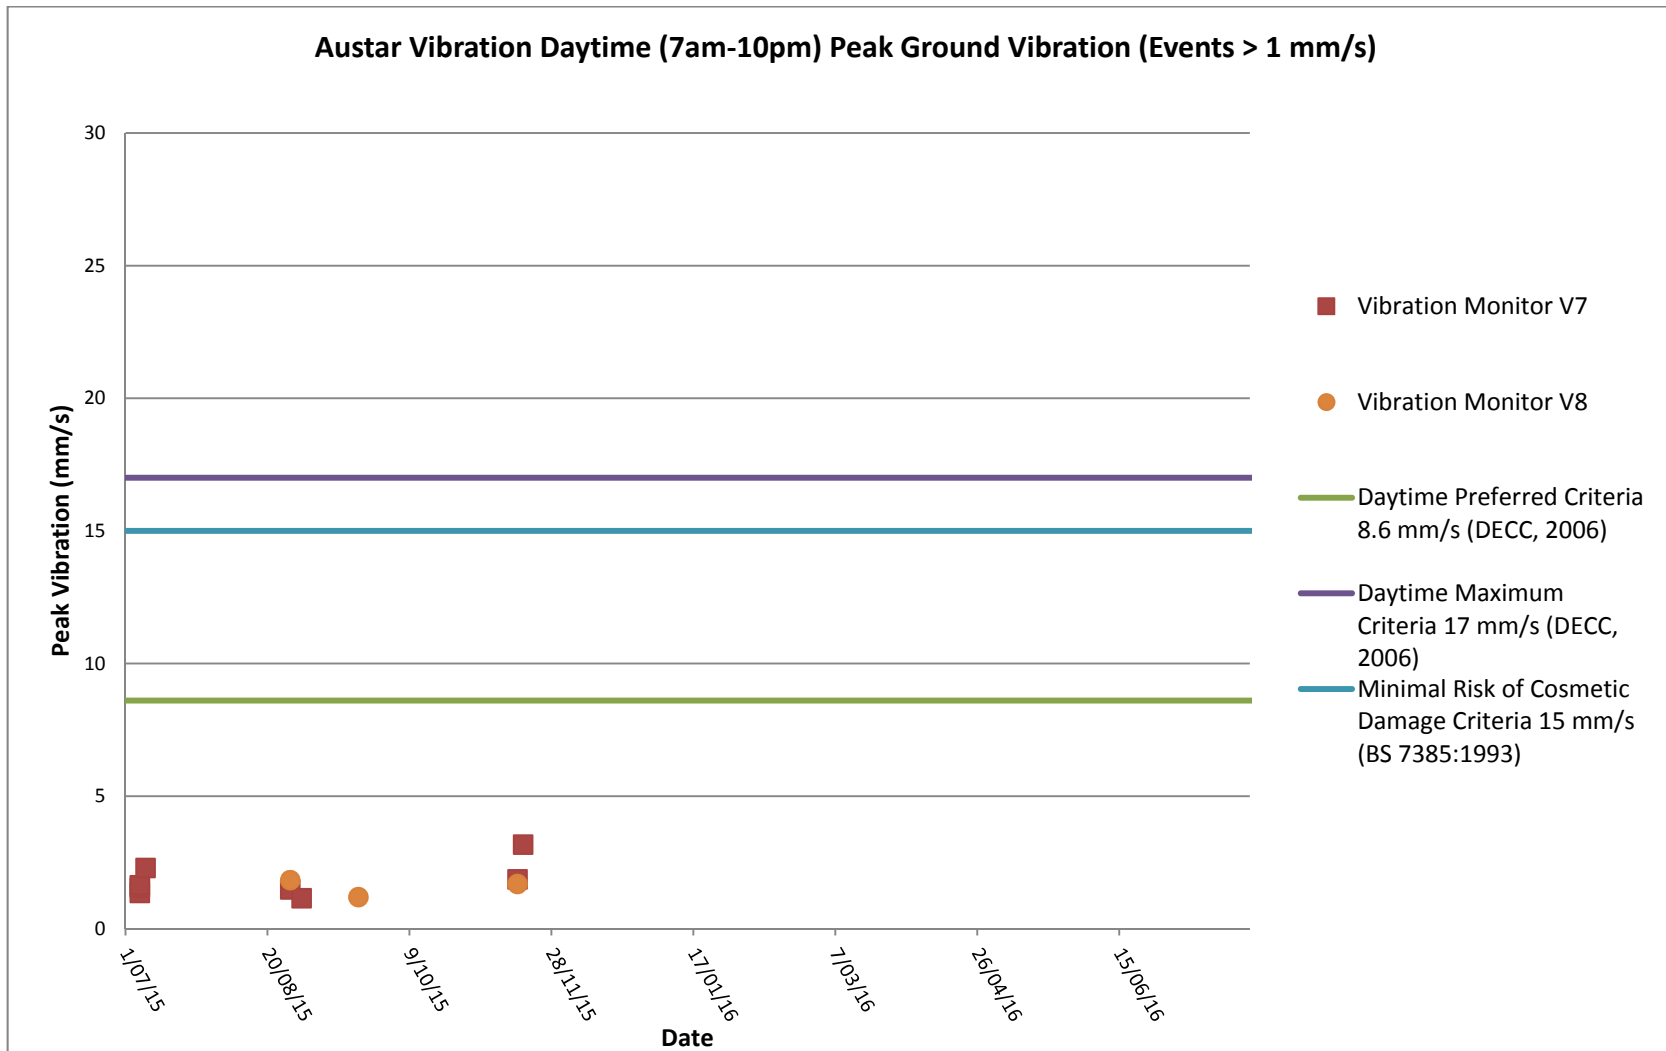
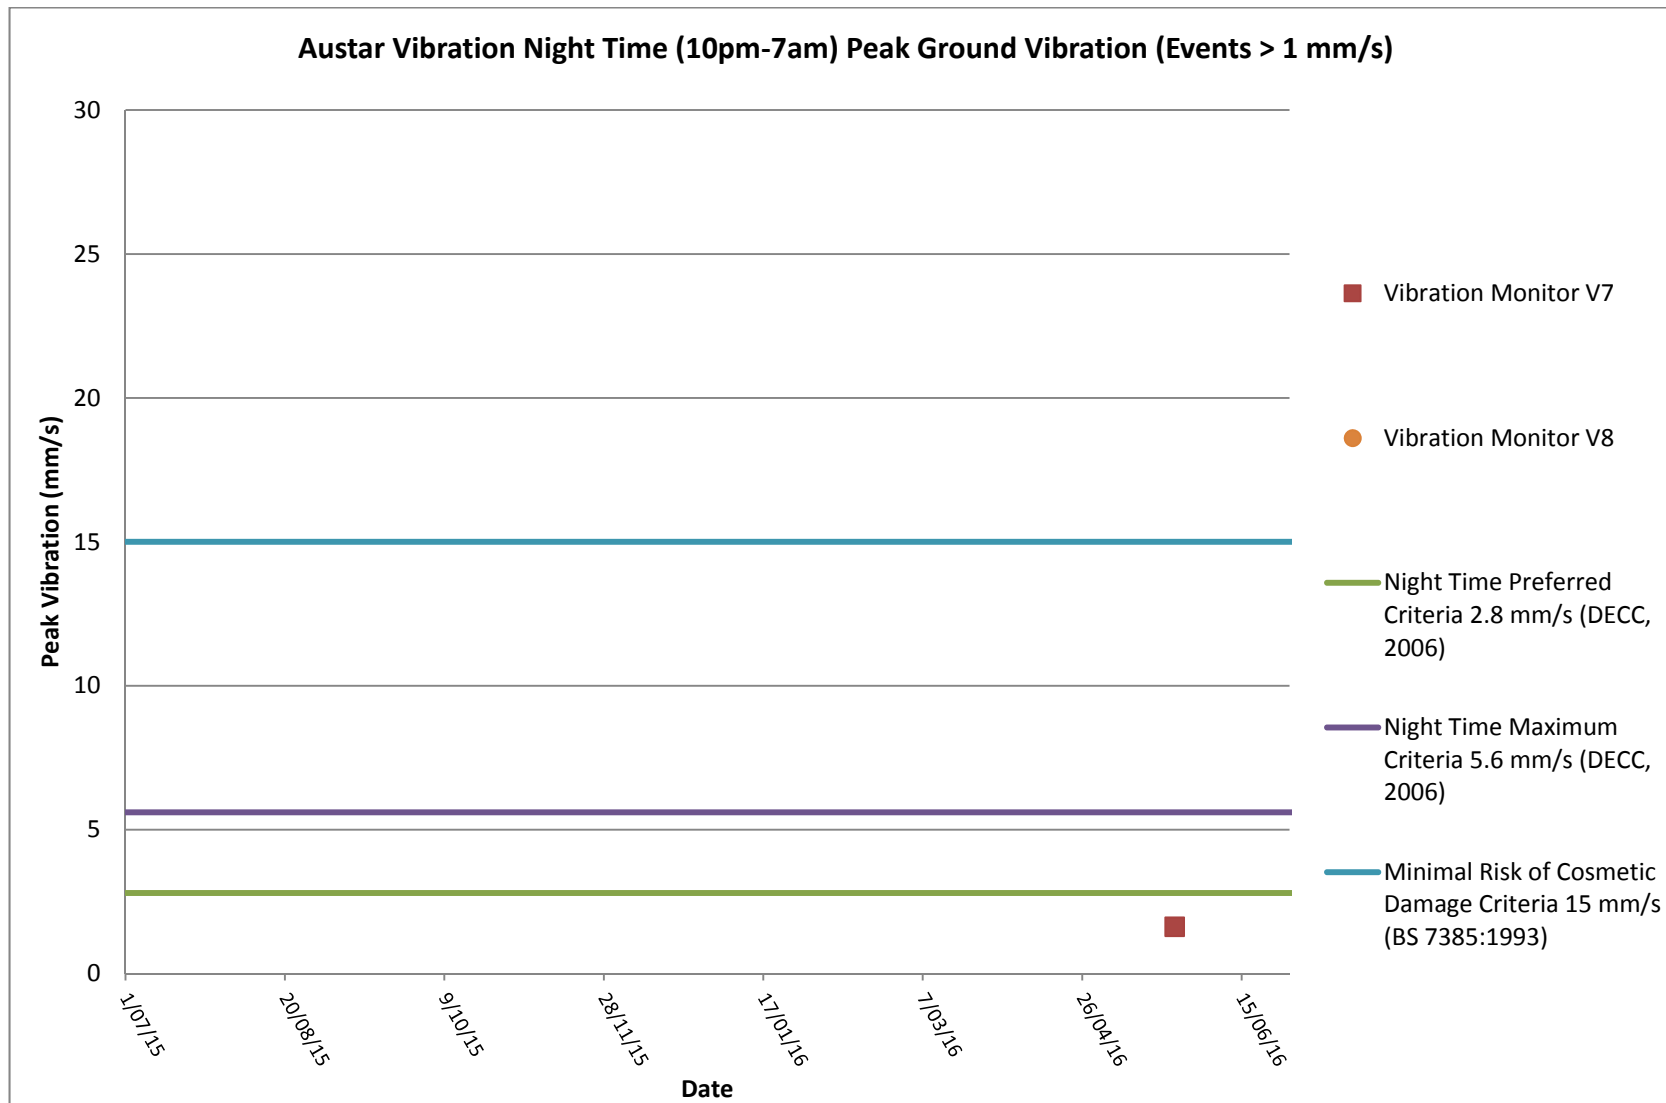
Vibration Monitoring Data

The maximum recorded event for the current reporting period was 3.17mm/s with the majority of events significantly less than this. Vibrations of this magnitude, whilst known to be noticeable for humans, are well below the lowest vibration level where a minimal risk of cosmetic damage may occur (15 mm/s). No vibration events during the reporting period exceeded DECC vibration criteria.
