# Annual Environmental Management Report

July 2016 – June 2017

<b>Name of operation</b>	Austar Coal Mine
<b>Name of operator</b>	Yancoal Mining Services Pty Ltd
<b>Development consent / project approval #</b>	Refer Table 1.2
<b>Name of holder of development consent / project approval</b>	Austar Coal Mine Pty Ltd
<b>Mining lease #</b>	Refer to Table 1.4
<b>Name of holder of mining lease</b>	Austar Coal Mine Pty Ltd
<b>Water licence #</b>	Refer Table 1.5
<b>Name of holder of water licence</b>	Austar Coal Mine Pty Ltd
<b>MOP start date</b>	<b>MOP 1:</b> 27 Nov 2015, <b>MOP 2:</b> 9 Sep 2016
<b>MOP end date</b>	<b>MOP 1:</b> 26 Nov 2022, <b>MOP 2:</b> 1 Jun 2023
<b>AEMR / Annual Review start date</b>	1 July 2016
<b>AEMR / Annual Review end date</b>	30 June 2017
<p><b>I, Gary Mulhearn, certify that this audit report is a true and accurate record of the compliance status of Austar Coal Mine for the period 1 July 2016 to 30 June 2017 and that I am authorised to make this statement on behalf of Austar Coal Mine Pty Ltd.</b></p> <p><i>Note.</i></p> <p>a) <i>The Annual Environmental Management Report is an ‘environmental audit’ for the purposes of section 122B(2) of the Environmental Plann

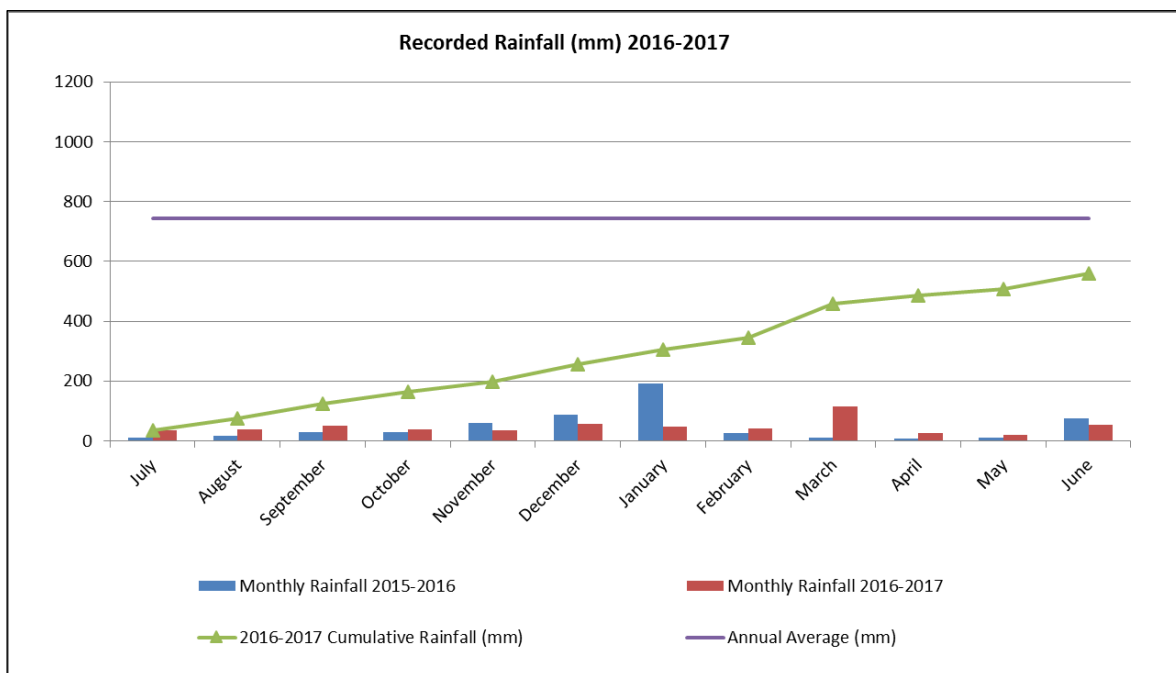
**FIGURE 3-2 RECORDED RAINFALL AT AUSTAR METEOROLOGICAL STATION (MM) 2016-2017**

Total Monthly Rainfall (mm)												
Jul	Aug	Sep	Oct	Nov	Dec	Jan	Feb	Mar	Apr	May	Jun	Total
35.6	39.0	50.2	38.8	35.8	58.2	46.4	41.2	114.4	27.0	19.6	52.4	<b>558.6</b>
Number of Rain Days (>0.2mm)												
13	13	14	10	9	8	14	13	20	14	13	19	<b>160</b>

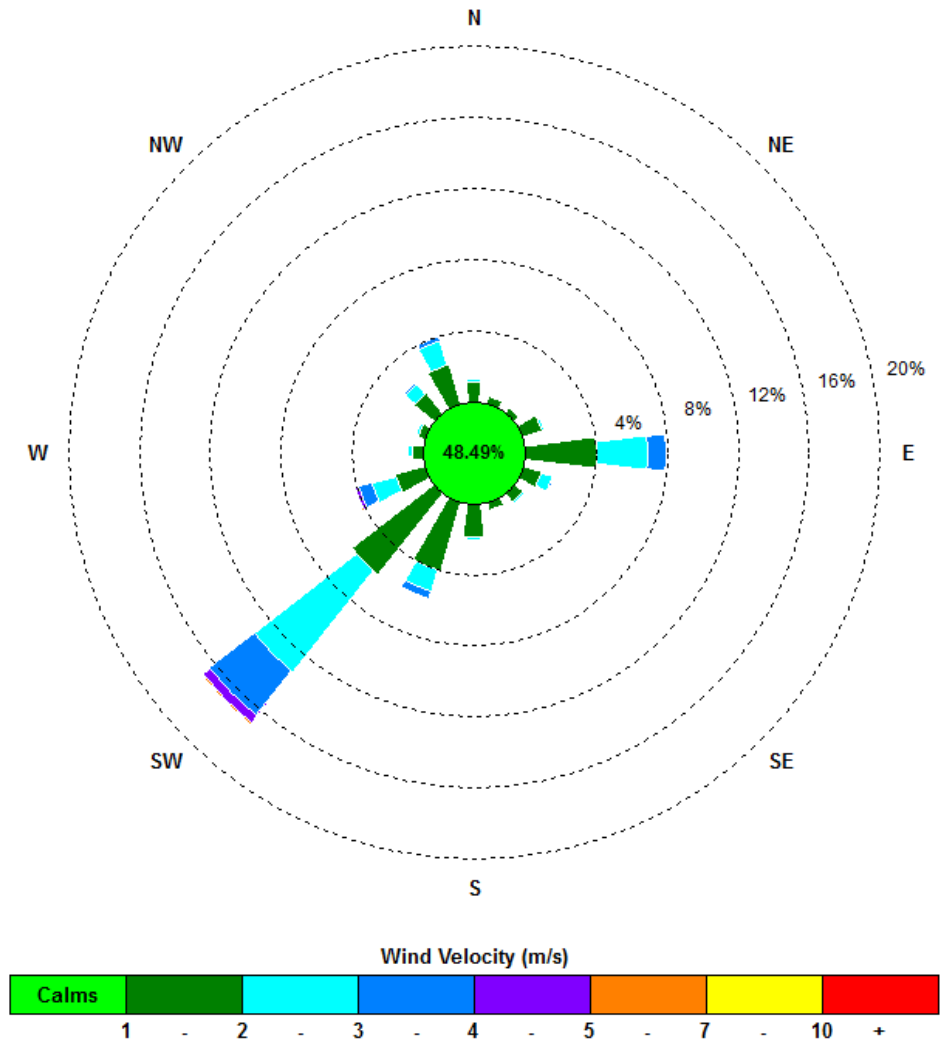
**FIGURE 3-3 MONTHLY AVERAGE WIND ROSE 2016-2017**

Month	Mean Wind Speed (m/s)	Mean Maximum Wind Speed (m/s)	Dominant Wind Direction
July 2016	1.0	7.6	NNW
August 2016	0.9	7.2	SW
September 2016	0.9	8.0	NNW
October 2016	1.2	9.5	SW
November 2016	1.1	8.6	E
December 2016	0.9	8.2	E
January 2017	1.0	8.2	E
February 2017	1.0	8.5	E
March 2017	1.3	7.8	SW
April 2017	1.0	7.3	SW
May 2017	0.8	6.4	SW
June 2017	1.2	7.1	SW

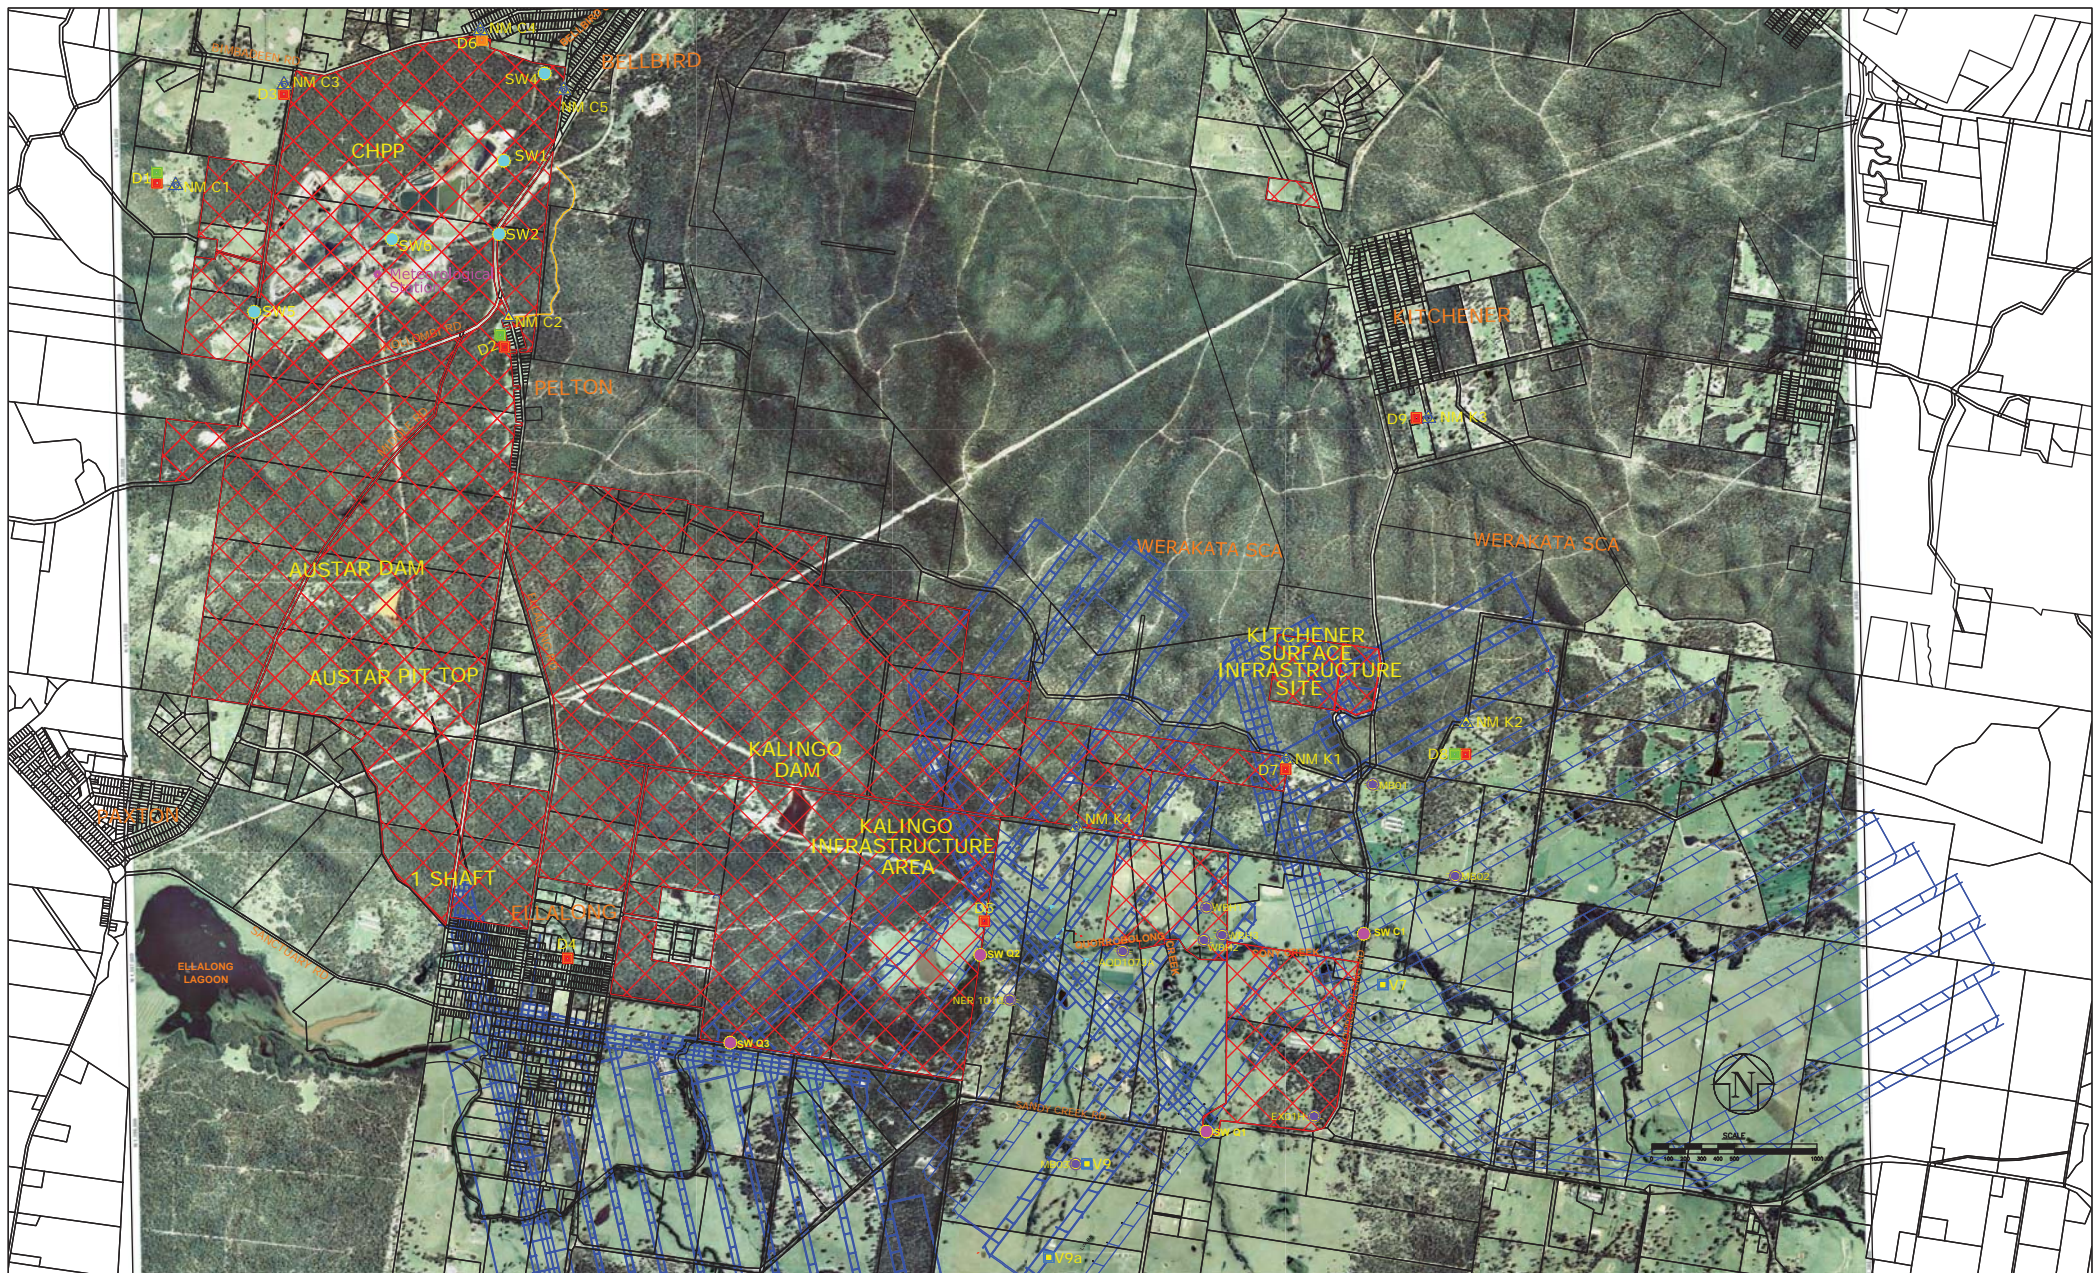
<b>AUSTAR COAL MINE</b>	
<b>Plan 2: Austar Environmental Monitoring Network</b>	
SCALE	Not to scale
DRAWING No.	Environmental/ Monitoring Plan A3

NM 1010	Ground Water Monitor	D5	High Volume Air Sampler / Dust Gauge
NM K1	Noises Monitors	D6	Continuous Dust Monitor
V7	Vibration Monitors	SW 2	Surface Water EPL Sample Points
AUSTAR OWNED LAND	SW C1	SW C2	Coney Creek Sample Points
	SW C1	SW C2	Quomabalong Creek Sample Points

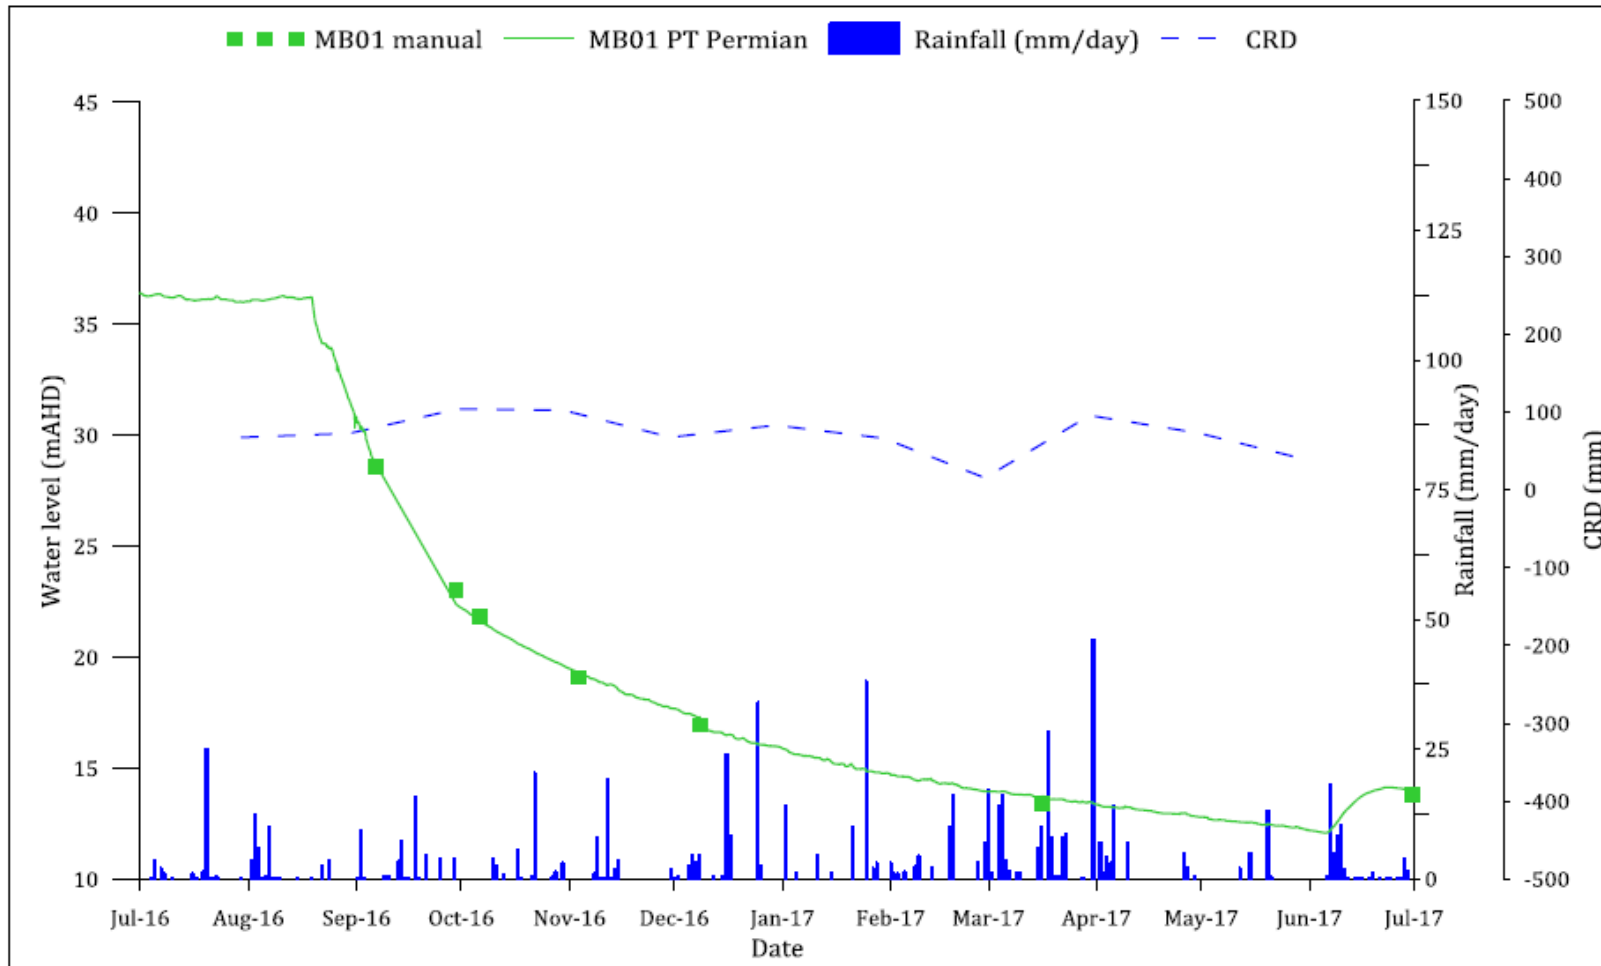
### Stage 3 MB01 Sandstone Hydrograph

- Monitoring of groundwater level in MB01 commenced on 6 February 2015 and is located over longwall A9 adjacent to the already extracted longwall A8. The groundwater level in Stage 3 monitoring bore MB01 began to decrease suddenly on 19 August 2016. Austar commissioned increased frequency of monitoring and analysis of the decrease. The investigation found there was no additional inflow into the underground mine, the bore is located within a faulted zone, adjacent bores did not display a decrease in water level. The water level continued to decline at a slower rate from September 2016 until June 2017.

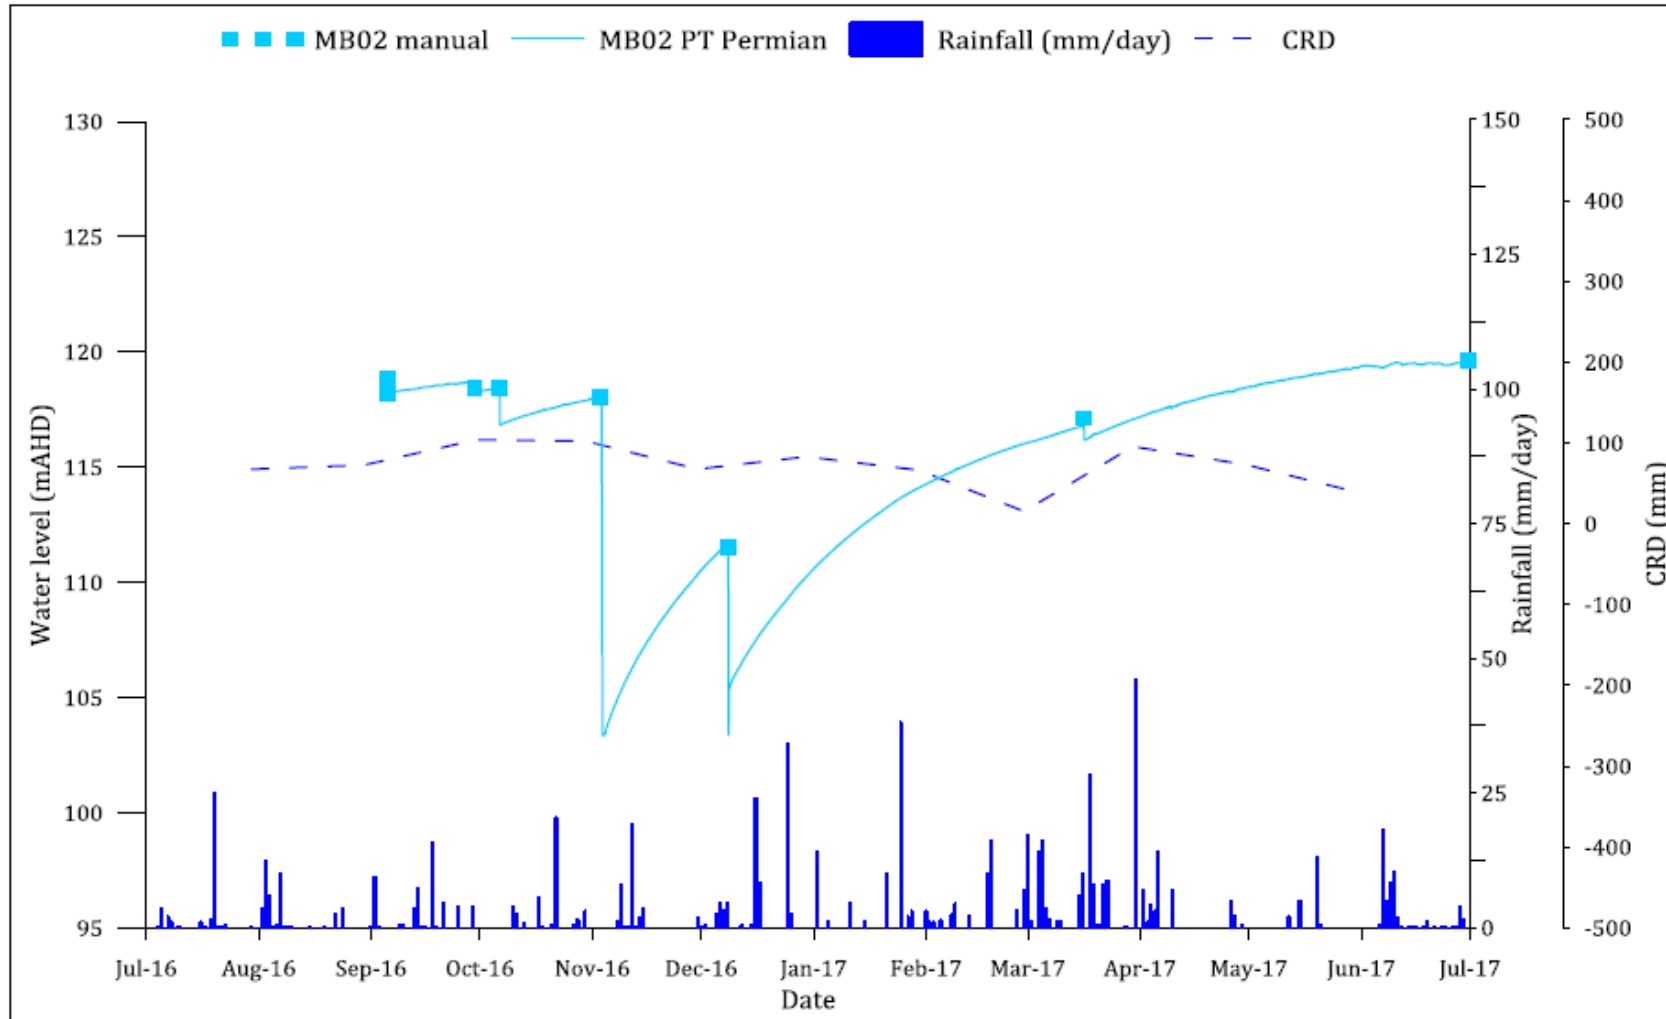
### Stage 3 MB02 Sandstone Hydrograph

- Monitoring of groundwater level in MB02 commenced in May 2015 and was initially monitored manually. A water level logger was installed in September 2016. This monitoring bore is located over longwall A11 in the Stage 3 area, some distance away from active mining in the reporting period. This bore appears to be screened in a unit of very low hydraulically permeability. This can be observed through very slow recovery rates of the water level between monitoring events where the bore was purged prior to sampling. The purging method for sampling was stopped from March 2017 to attempt to monitor water level without purging interruptions. The groundwater level in monitoring bore MB02 has recovered between April and June 2017 since the purging sampling method ceased.

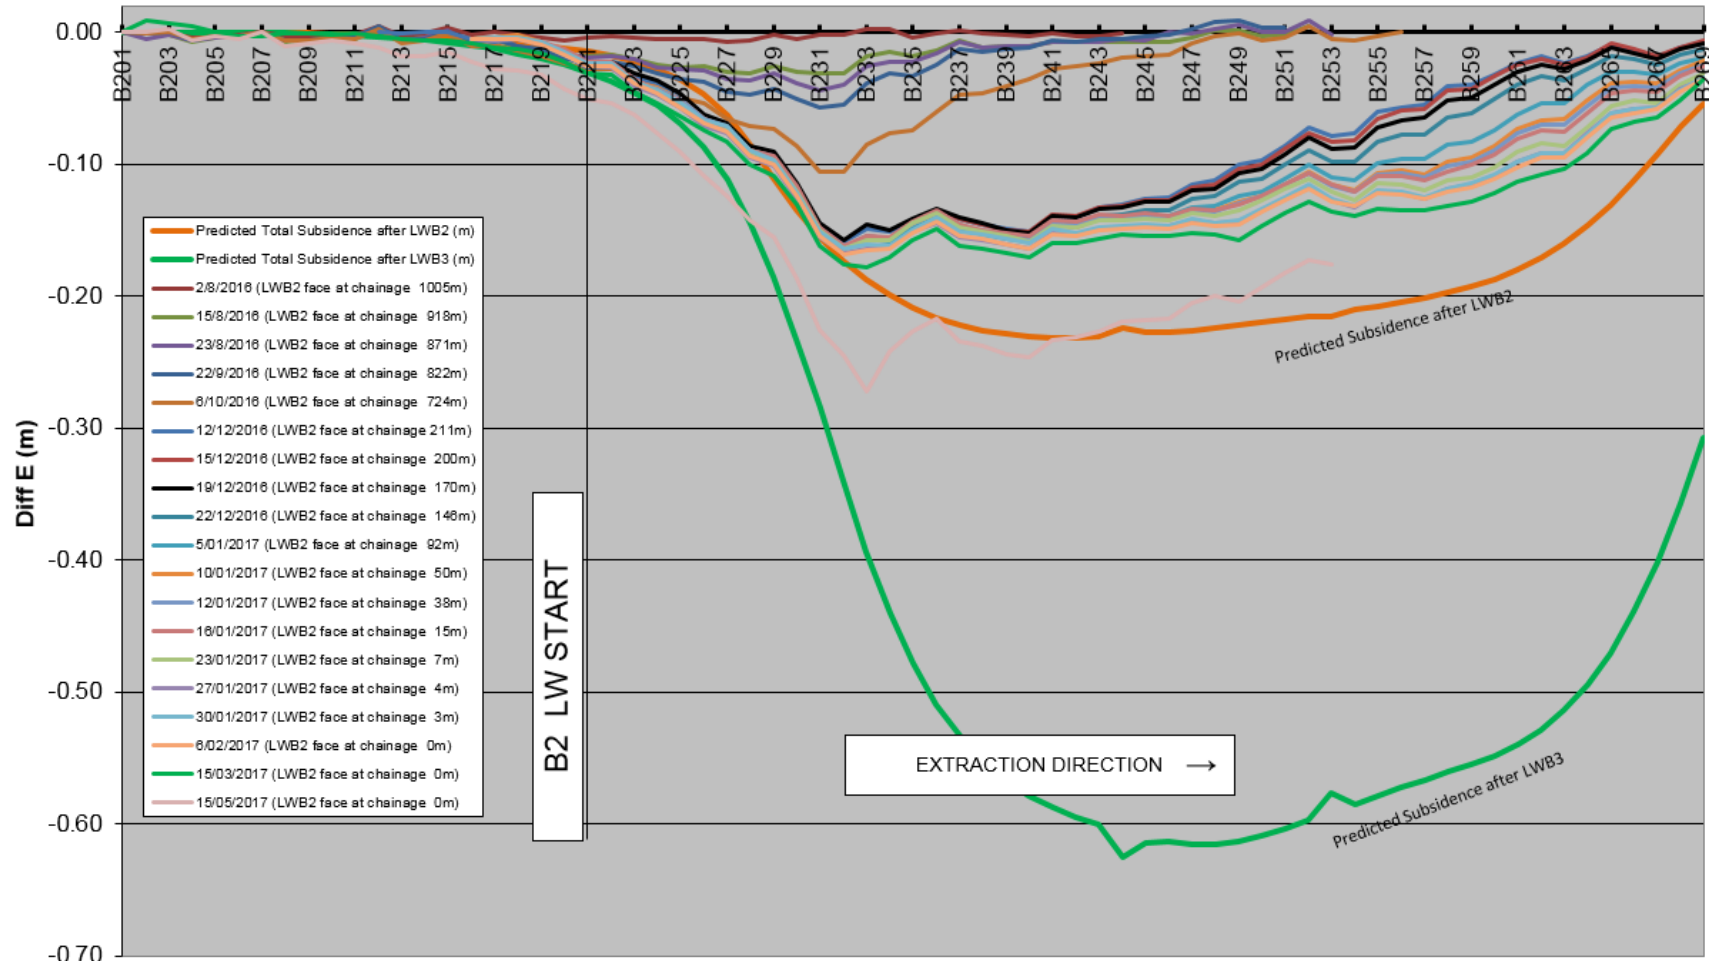
**Subsidence- LINE "B2"**

INITIAL SURVEY 4/7/2016
